**REPAIR, EVALUATION, MAINTENANCE, AND  
REHABILITATION RESEARCH PROGRAM**

TECHNICAL REPORT REMR-CS-8

**IN SITU REPAIR OF DETERIORATED  
CONCRETE IN HYDRAULIC STRUCTURES:  
FEASIBILITY STUDIES**

May 1987  
Final Report

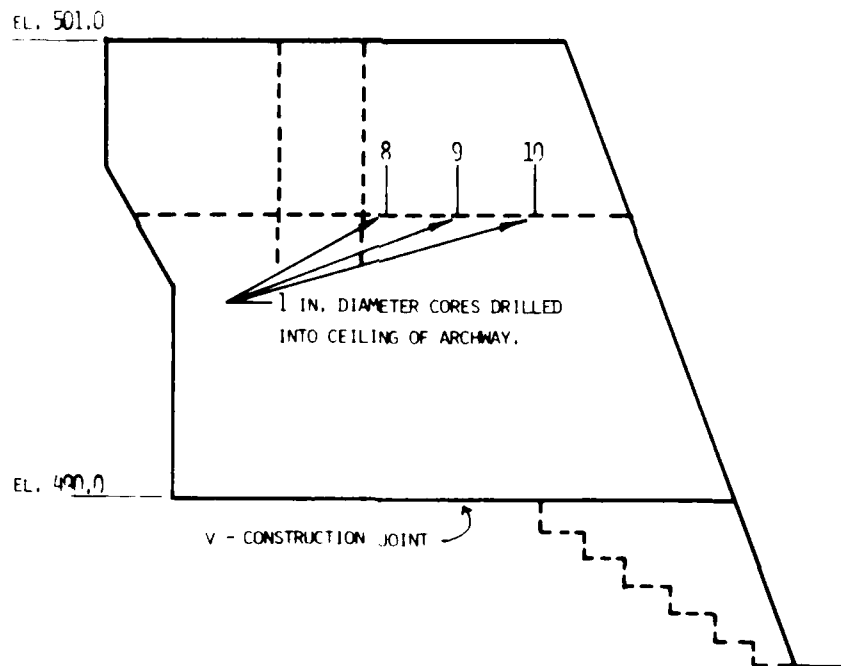
Figure 10. East elevation showing location of injection ports (Flock and Walleser, 1983).

Epoxy injection was started in the middle of the archway ceiling at Port No. 9 (refer to Figures 10-12). Pumping was continued, while the epoxy reached injection Ports Nos. 2, 3, and 12 on the downstream face. The operation was then moved to the upstream ceiling port (No. 8). The contractor had difficulty maintaining a seal around the injection packer. In addition, leakage of epoxy was noted at the bottom edge of the access manhole and adjacent to the electrical conduits embedded in the archway ceiling. An attempt was made to inject epoxy into Port No. 10; however, it was impossible, even at a pressure of 160 psi.

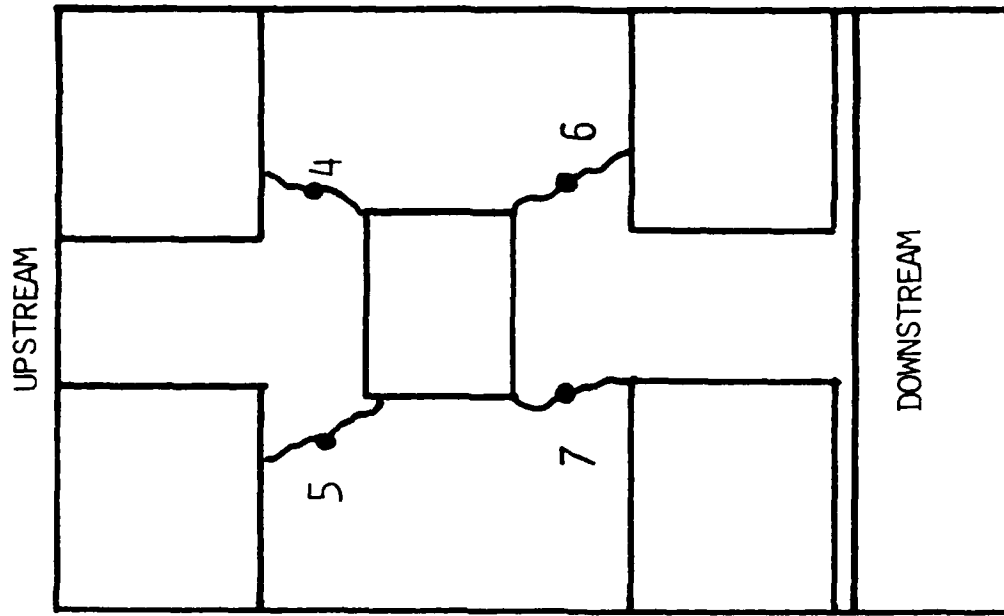
Figure 12. Top view showing major cracks and locations of injection ports (Flock and Walleser, 1983).

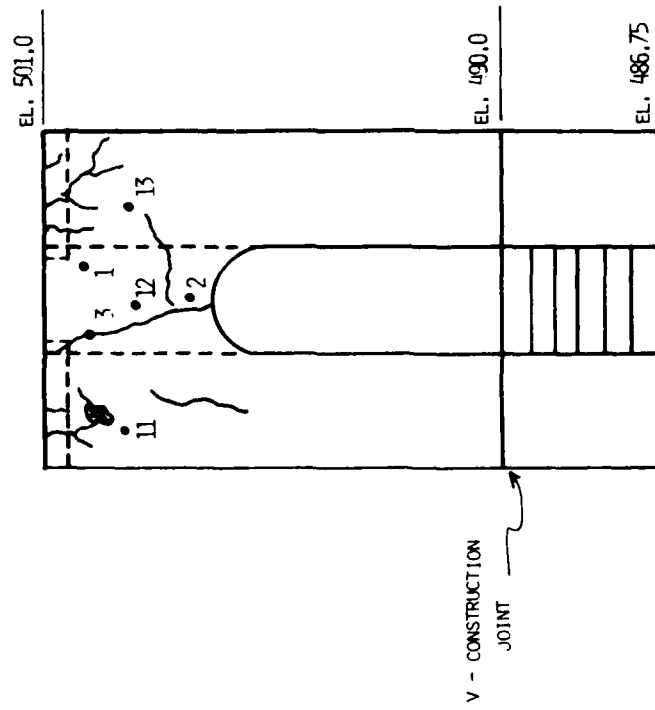
Figure 11. Downstream view showing major cracks and locations of injection ports (Flock and Walleser, 1983).

The injection operation was then moved to Port No. 12 on the downstream face. Again, problems were encountered with leakage at the packer seal. Injection was moved to Port No. 11. Leaks through the seal coat developed at pop-outs and along wider cracks on the downstream face. As epoxy was pumped into the pier, water was driven from the cracks and appeared on the surface of the pier at elevations below the seal coat. Epoxy also appeared at several small cracks in these areas. Injection was continued at Port No. 13, then at Port No. 1. Epoxy ponded at the top of the downstream east grout pad while pumping at Port No. 1. Injection was continued at Port No. 6 on the pier top. The last port injected was No. 7, also on top. This port was injected until epoxy appeared at the handhold at the top of the access manhole. The injection packers were then removed and all ports were sealed with epoxy. The pier was injected for a total time of approximately 34 hours. Approximately 8.4 gal of epoxy were injected into the pier.

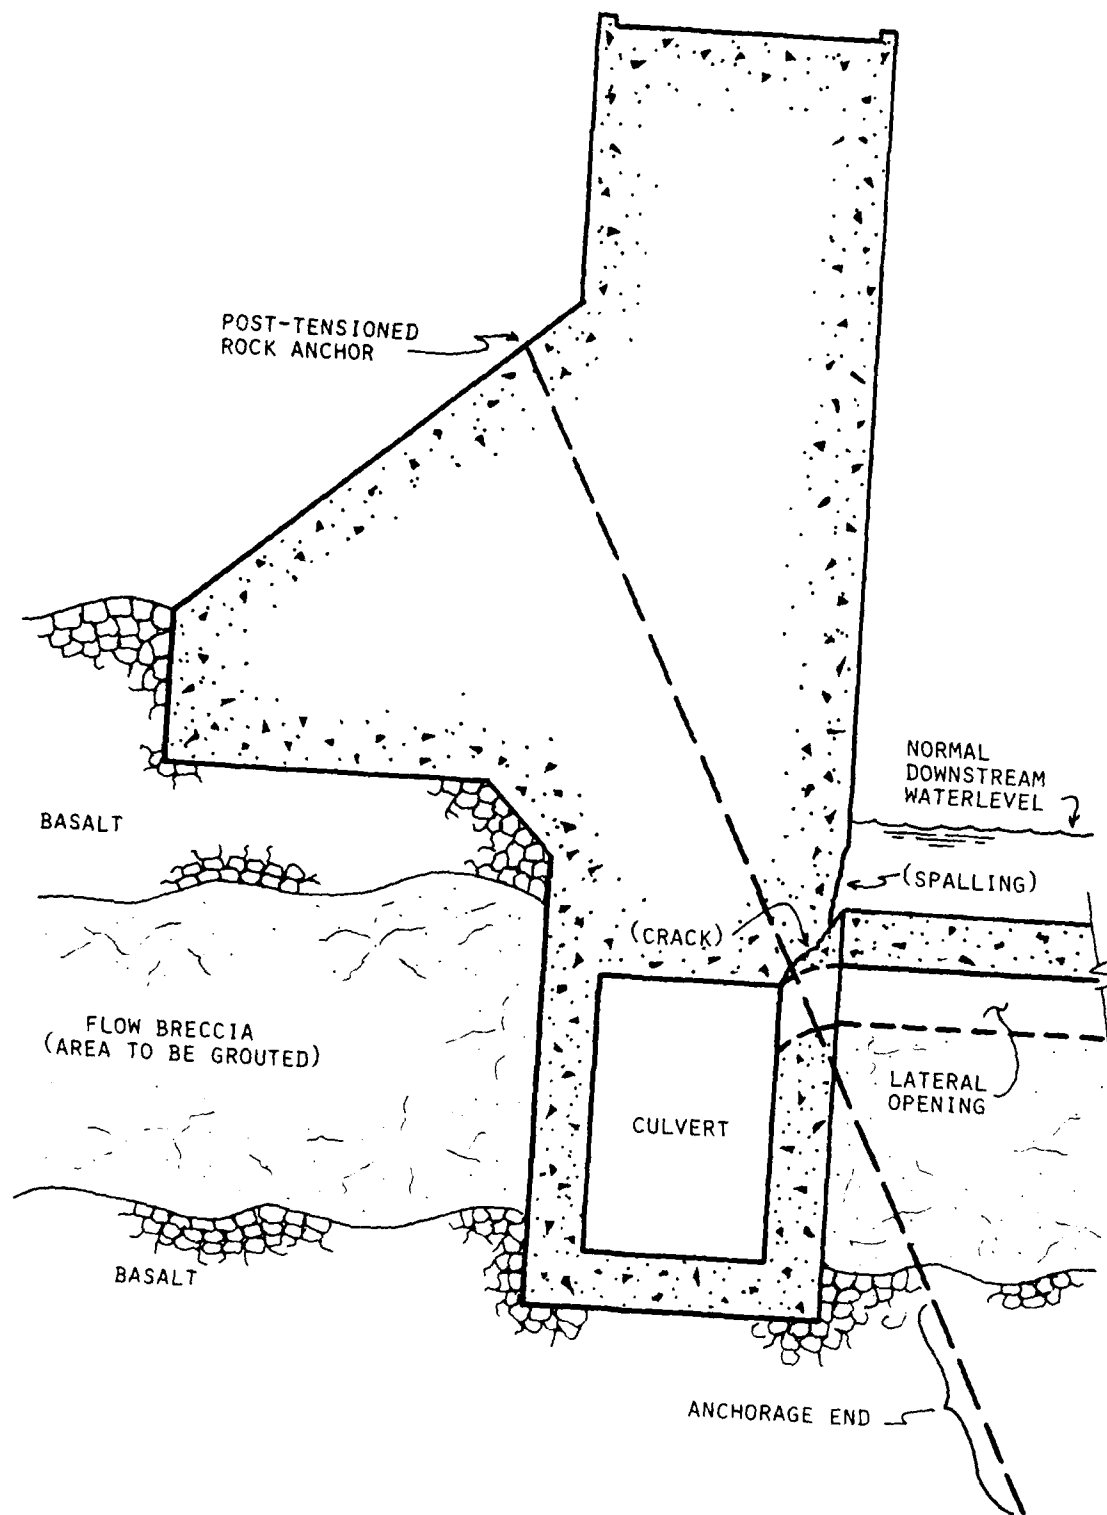
During an inspection in 1975, significant structural cracking and related spalling were discovered in two of the lock monoliths, monoliths 17 and 19. By 1979, cracking and spalling had been detected in four additional monoliths, monoliths 13, 15, 21, and 23. The structural distress in the monoliths consisted of cracks that originated at and propagated from the upper inside corner of the filling and emptying culvert and terminated at the surface of the wall in the lock chamber. Because of the continued progression of the cracking and spalling, a series of remedial repair procedures were devised and implemented to halt and correct the ongoing deterioration (Adhesive Engineering Bulletin, 1981b, Barlow, 1986, and Neuberger, 1982).

Figure 15. Cross-section of lock wall, showing details of crack location and supporting rock mass.

In 1981, Phase Two of the repair program was performed. This phase of the repair program involved the installation of 73 rock anchors and the injection of structural epoxy adhesive into the crack network. Finite element analysis had shown that the forces induced by the rock bolt anchors would substantially reduce the tensile stresses in the cracked areas at the top of the culvert.

Subsequent to the grouting of the foundation, 10-in. diameter rock anchor holes were drilled from the outside of the monoliths into the basalt rock below. This work was carried on without interrupting lock
